Feather River, RM 28.5R (LM 14.5, Sutter County LD 1 West)

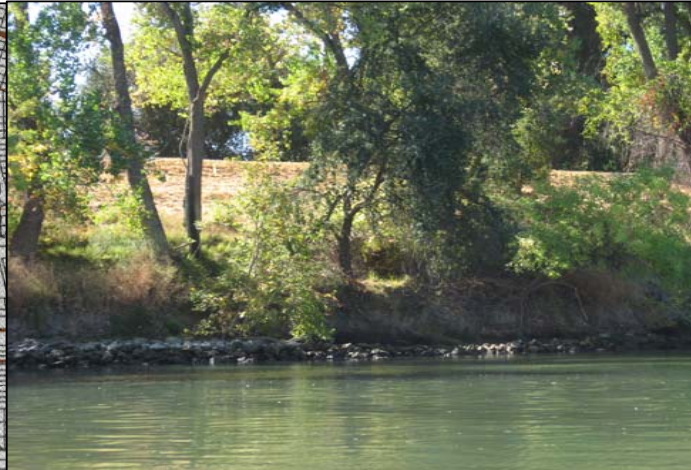
Site Photograph

Criteria	Score	Notes
Bank Slope (*2)	2	2:1 slope
Berm Width (*2) - Estimated	5	0 to 15 ft
Location of erosion	3	toe
Bank Stability	1	caves from tree popouts
Site Relative to Bend	1	relatively straight
Vegetation Cover	1	70 to 80%
Tree Hazard	4	large trees with exposed roots
Soil Type (*2)	4	sands and silts
Velocity (*2)	3	4.5 ft/s (UNET)
Human Usage	2	seasonal
Erosion Hazard	40	Calculate Erosion Hazard

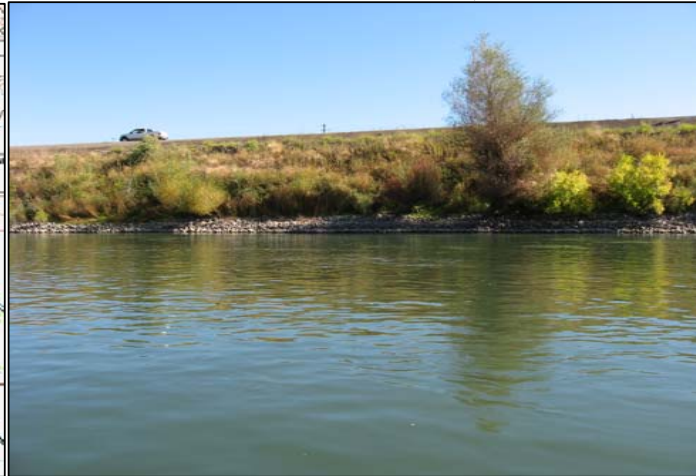
Site Photograph

Criteria	Score	Notes
Bank Slope (*2)	4	1:1 slope
Berm Width (*2) - Estimated	5	no berm
Location of erosion	4	toe and lower bank
Bank Stability	2	vertical section, less than half bank height
Site Relative to Bend	3	outside of gentle bend
Vegetation Cover	1	75%
Tree Hazard	0	no trees
Soil Type (*2)	2	clays and silts
Velocity (*2)	2	2.58 ft/s
Human Usage	3	monthly
Erosion Hazard	39	Calculate Erosion Hazard

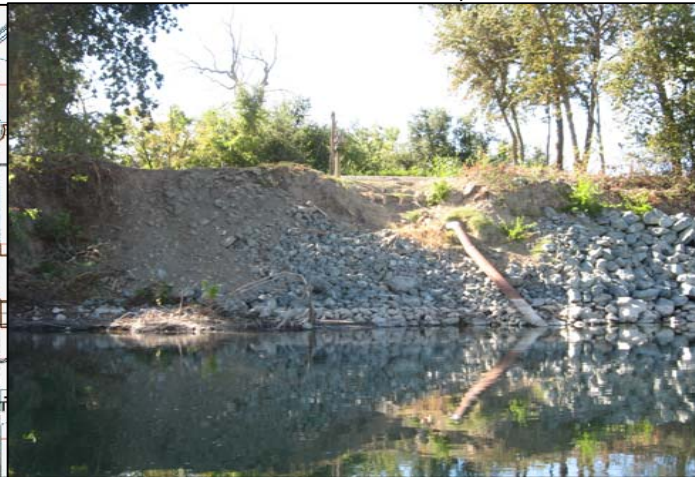
Site Photograph

Criteria	Score	Notes
Bank Slope (*2)	2	2:1 slope
Berm Width (*2) - Estimated	3	8 to 10 ft
Location of erosion	2	full bank
Bank Stability	2	vertical sections, less than half bank height
Site Relative to Bend	0	inside of a bend
Vegetation Cover	3	30%
Tree Hazard	3	large trees
Soil Type (*2)	4	sands and silts
Velocity (*2)	3	3.41 ft/s
Human Usage	5	campground adjacent
Erosion Hazard	39	Calculate Erosion Hazard

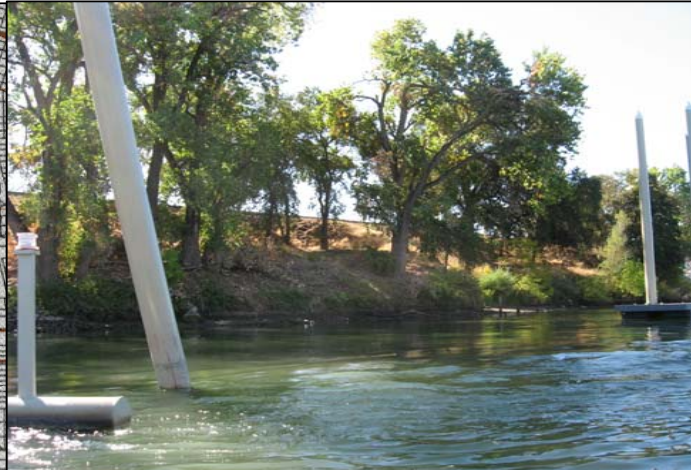
Site Photograph

Criteria	Score	Notes
Bank Slope (*2)	3	1.5:1 slope
Berm Width (*2) - Estimated	2	15 ft
Location of erosion	2	levee slope
Bank Stability	2	small vertical section
Site Relative to Bend	1	relatively straight
Vegetation Cover	2	40%
Tree Hazard	3	large trees
Soil Type (*2)	4	sands and silts
Velocity (*2)	3	4.84 ft/s
Human Usage	5	paths and human debris, adjacent to hotel
Erosion Hazard	39	Calculate Erosion Hazard

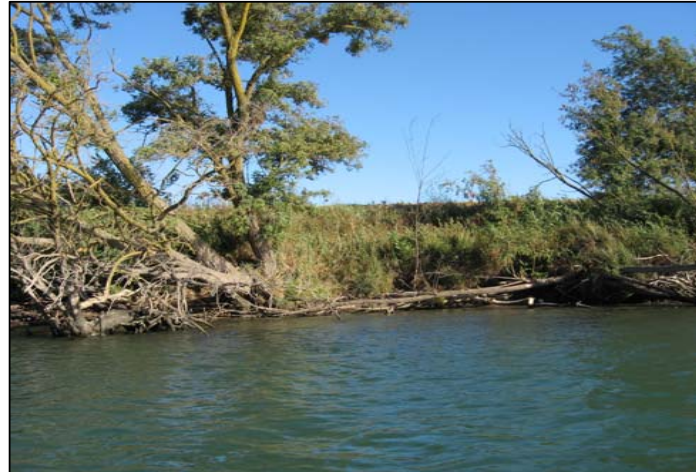
Site Photograph

Criteria	Score	Notes
Bank Slope (*2)	4	1.5:1 slope
Berm Width (*2) - Estimated	3	5 ft of berm
Location of erosion	2	mid and lower bank
Bank Stability	0	no stability issues
Site Relative to Bend	3	outside of a slight bend
Vegetation Cover	0	90%
Tree Hazard	5	large leaning trees, exposed roots
Soil Type (*2)	4	sands and silts
Velocity (*2)	3	4.3 ft/s
Human Usage	1	occassional, lots of veg
Erosion Hazard	39	Calculate Erosion Hazard

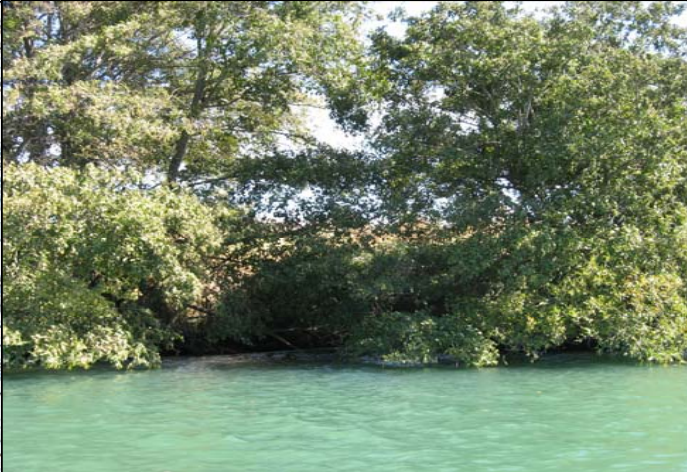
Site Photograph

Criteria	Score	Notes
Bank Slope (*2)	3	1.5:1 slope
Berm Width (*2) - Estimated	4	less than 5 ft
Location of erosion	3	toe
Bank Stability	2	some vertical sections, less than half bank height
Site Relative to Bend	1	straight
Vegetation Cover	0	dense, 95%
Tree Hazard	5	trees with exposed roots and leaning
Soil Type (*2)	4	sands and silts
Velocity (*2)	3	4.01 ft/s
Human Usage	0	too dense with vegetation for human use
Erosion Hazard	39	Calculate Erosion Hazard

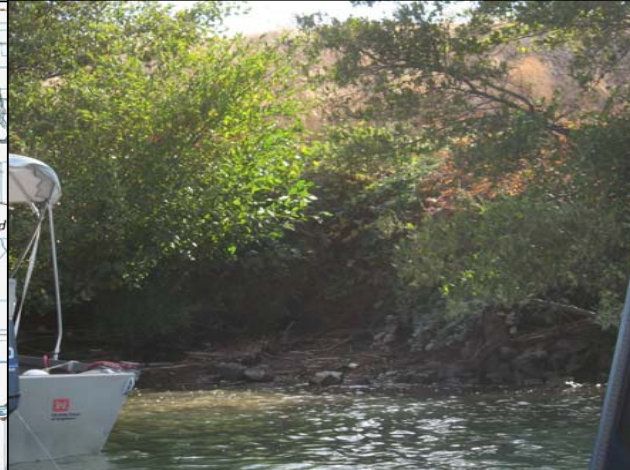
Site Photograph

Criteria	Score	Notes
Bank Slope (*2)	2	2:1 slope
Berm Width (*2) - Estimated	4	3 to 6 ft
Location of erosion	3	toe
Bank Stability	5	vertical sections, less than half bank height, beaver burrows
Site Relative to Bend	2	just downstream of a bend
Vegetation Cover	2	about 40%
Tree Hazard	0	no trees
Soil Type (*2)	1	clays
Velocity (*2)	5	10.9 ft/s
Human Usage	3	monthly
Erosion Hazard	39	Calculate Erosion Hazard

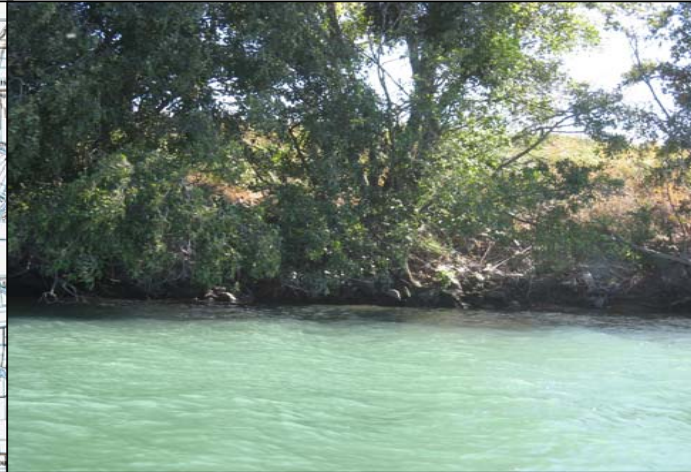
Site Photograph

Criteria	Score	Notes
Bank Slope (*2)	3	1.5:1 slope
Berm Width (*2) - Estimated	2	15 ft
Location of erosion	2	middle and lower bank
Bank Stability	4	vertical sections, greater than half bank height
Site Relative to Bend	4	outside of a 90 degree bend
Vegetation Cover	1	80%
Tree Hazard	0	no trees
Soil Type (*2)	4	sands and silts
Velocity (*2)	3	3.68 ft/s
Human Usage	4	adjacent to public road, debris, weekly
Erosion Hazard	39	Calculate Erosion Hazard

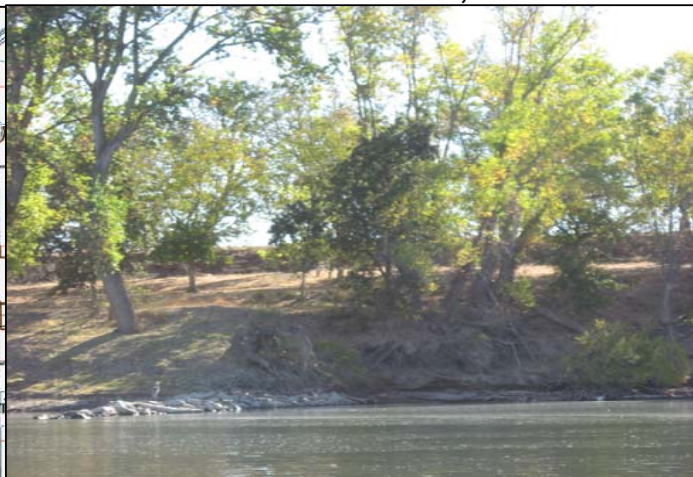
Site Photograph

Criteria	Score	Notes
Bank Slope (*2)	3	1.5:1 slope
Berm Width (*2) - Estimated	1	25 to 30 ft
Location of erosion	4	full bank and toe
Bank Stability	5	caves and some vertical sections
Site Relative to Bend	0	inside of bend
Vegetation Cover	2	30 to 40%
Tree Hazard	5	large trees with exposed roots and leaning
Soil Type (*2)	2	clays and silts
Velocity (*2)	5	5.08 ft/s plus eddy off adjacent rock
Human Usage	1	occassional
Erosion Hazard	39	Calculate Erosion Hazard

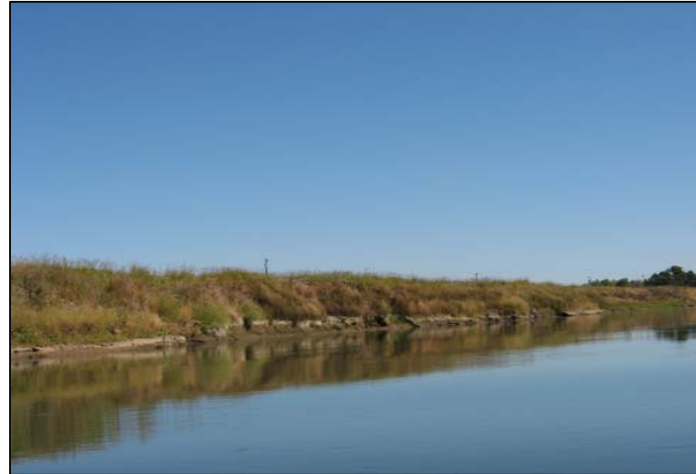
Site Photograph

Criteria	Score	Notes
Bank Slope (*2)	3	1.5:1 slope
Berm Width (*2) - Estimated	2	10 ft
Location of erosion	4	berm and toe
Bank Stability	5	vertical sections, full bank height, lots of beaver holes
Site Relative to Bend	1	straight
Vegetation Cover	2	60%
Tree Hazard	0	no trees
Soil Type (*2)	4	sand and silts
Velocity (*2)	3	4.0 ft/s
Human Usage	2	seasonal
Erosion Hazard	38	Calculate Erosion Hazard

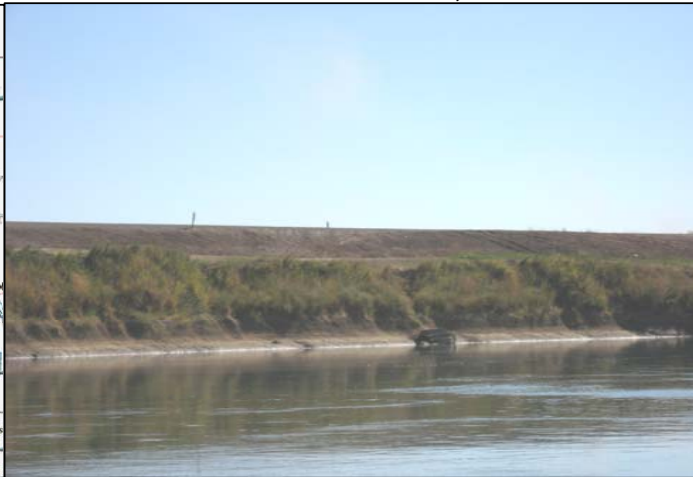
Site Photograph

Criteria	Score	Notes
Bank Slope (*2)	3	1.5:1 slope
Berm Width (*2) - Estimated	2	15 ft
Location of erosion	4	toe and bank
Bank Stability	2	vertical sections, less than half bank height
Site Relative to Bend	5	outside of a tight bend
Vegetation Cover	2	60%
Tree Hazard	0	no trees
Soil Type (*2)	4	sands and silts
Velocity (*2)	3	3.37 ft/s
Human Usage	1	daily, stairs and path down
Erosion Hazard	38	Calculate Erosion Hazard

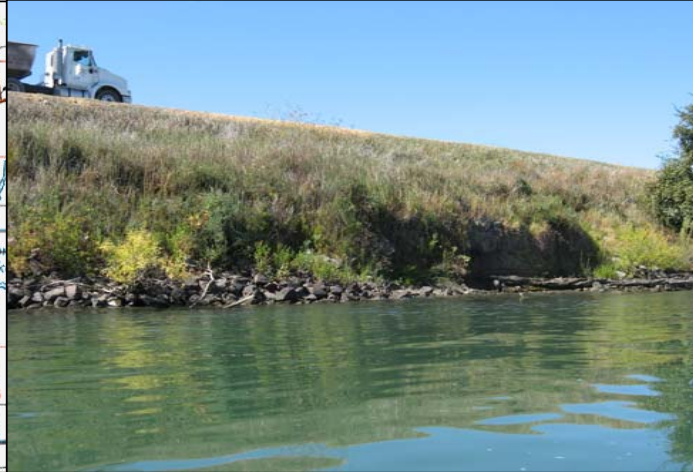
Site Photograph

Criteria	Score	Notes
Bank Slope (*2)	3	1.5:1 slope
Berm Width (*2) - Estimated	4	less than 5 ft
Location of erosion	4	lower bank and toe
Bank Stability	2	vertical sections, less than half bank slope
Site Relative to Bend	1	straight
Vegetation Cover	2	40-50%
Tree Hazard	0	no trees
Soil Type (*2)	2	clays and silts
Velocity (*2)	4	5.46 ft/s
Human Usage	3	monthly
Erosion Hazard	38	Calculate Erosion Hazard

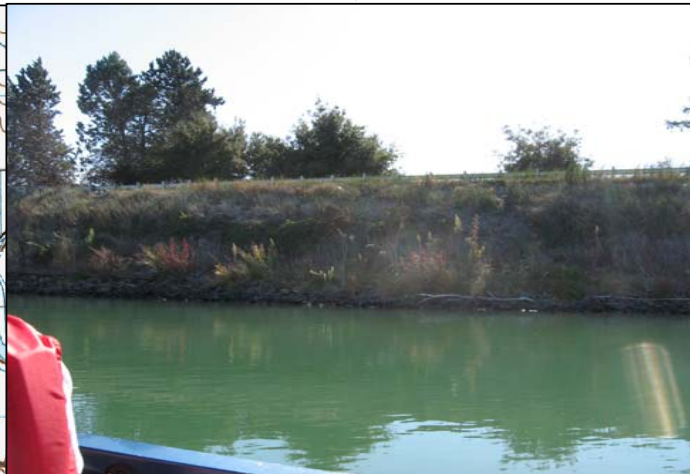
Site Photograph

Criteria	Score	Notes
Bank Slope (*2)	3	1.5:1 slope
Berm Width (*2) - Estimated	5	no berm
Location of erosion	1	levee slope
Bank Stability	0	no vertical sections or caves
Site Relative to Bend	1	straight
Vegetation Cover	1	70%
Tree Hazard	0	no trees
Soil Type (*2)	4	sands and silts
Velocity (*2)	4	5.23 ft/s
Human Usage	3	adjacent to road but no paths, monthly
Erosion Hazard	38	Calculate Erosion Hazard

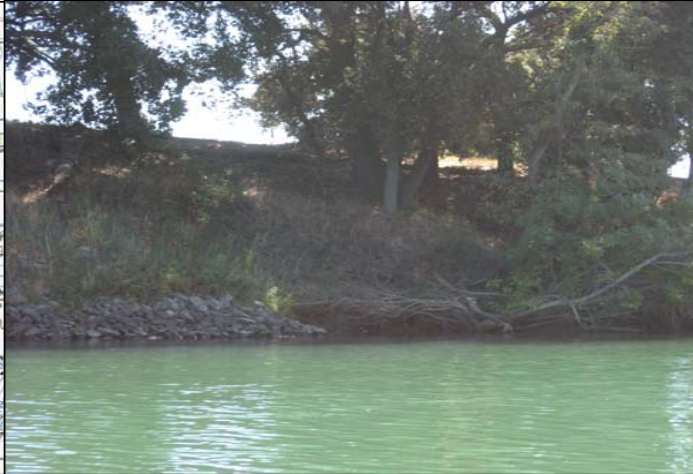
Site Photograph

Criteria	Score	Notes
Bank Slope (*2)	3	1.5:1 slope
Berm Width (*2) - Estimated	3	5 ft
Location of erosion	4	lower bank and toe
Bank Stability	1	caves from tree popouts
Site Relative to Bend	0	inside of a bend
Vegetation Cover	3	40%
Tree Hazard	5	large trees, exposed roots and leaning
Soil Type (*2)	2	clays and silts
Velocity (*2)	3	4.76 ft/s
Human Usage	3	monthly
Erosion Hazard	38	Calculate Erosion Hazard

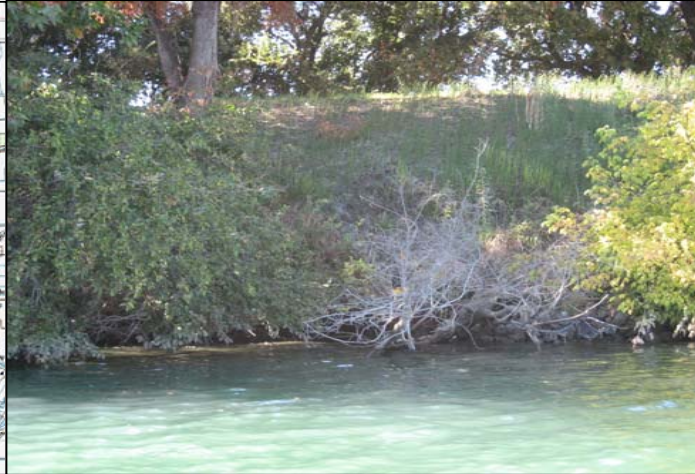
Site Photograph

Criteria	Score	Notes
Bank Slope (*2)	4	1:1 slope
Berm Width (*2) - Estimated	3	about 5 ft
Location of erosion	2	lower bank
Bank Stability	0	no vertical sections or caves
Site Relative to Bend	4	outside of a 90 degree bend
Vegetation Cover	0	90%
Tree Hazard	4	large trees with exposed roots
Soil Type (*2)	2	clays and silts
Velocity (*2)	3	4.45 ft/s
Human Usage	4	weekly
Erosion Hazard	38	Calculate Erosion Hazard

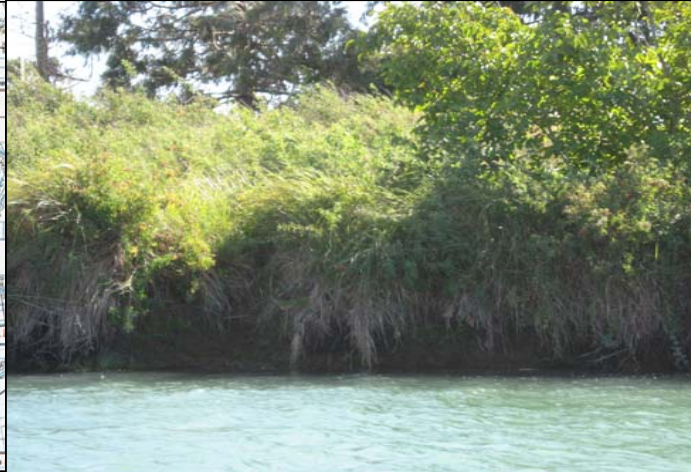
Site Photograph

Criteria	Score	Notes
Bank Slope (*2)	3	1.5:1 slope
Berm Width (*2) - Estimated	2	10 ft
Location of erosion	4	berm slope and toe
Bank Stability	1	caves
Site Relative to Bend	3	outside of a gentle bend
Vegetation Cover	0	80 to 90%
Tree Hazard	4	large trees with exposed roots
Soil Type (*2)	4	sands and silts
Velocity (*2)	3	3.95 ft/s
Human Usage	2	seasonal
Erosion Hazard	38	Calculate Erosion Hazard

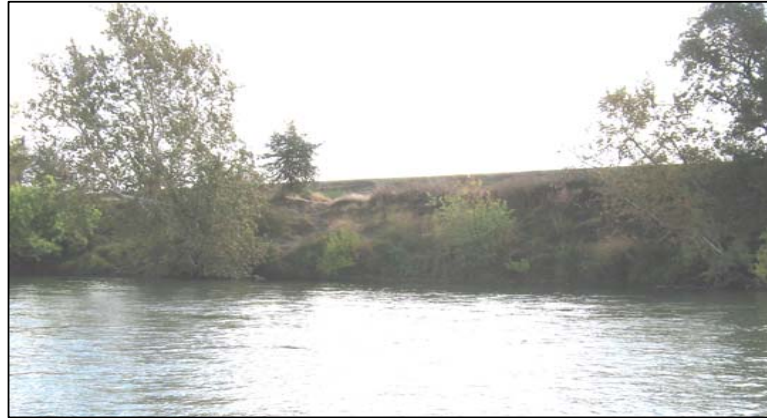
Site Photograph

Criteria	Score	Notes
Bank Slope (*2)	2	2:1 slope with some vertical sections
Berm Width (*2) - Estimated	1	25 to 30 ft
Location of erosion	3	whole bank
Bank Stability	2	vertical sections, less than half bank height
Site Relative to Bend	1	straight
Vegetation Cover	3	30 to 40 % cover
Tree Hazard	0	no trees in the erosion area
Soil Type (*2)	4	sands and silts
Velocity (*2)	5	10.6 ft/s
Human Usage	5	close to road, human debris evident
Erosion Hazard	38	Calculate Erosion Hazard

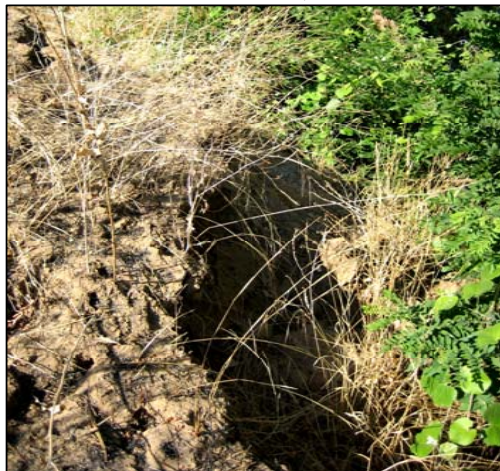
Site Photograph

Criteria	Score	Notes
Bank Slope (*2)	5	Vertical slope
Berm Width (*2) - Estimated	2	15 to 30 ft of berm
Location of erosion	5	Whole Bank
Bank Stability	5	vertical sections and beaver burrows
Site Relative to Bend	3	Outside of a bend, greater than 90 degrees
Vegetation Cover	2	About 60% cover
Tree Hazard	0	no trees
Soil Type (*2)	2	Clays and Silts
Velocity (*2)	2	2.84 ft/s
Human Usage	1	Occassional usage
Erosion Hazard	38	Calculate Erosion Hazard

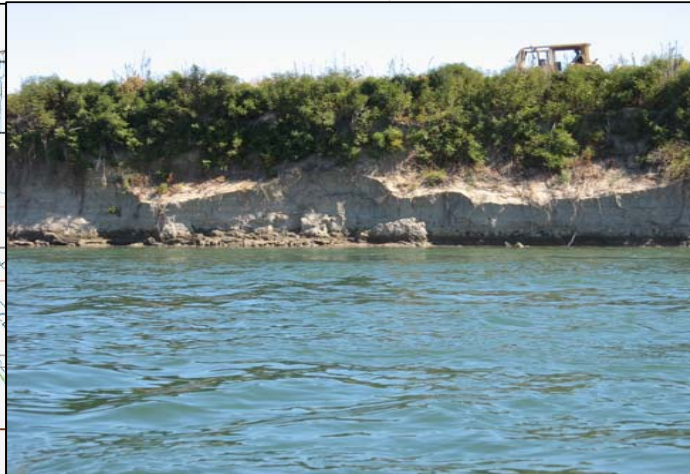
Site Photograph

Criteria	Score	Notes
Bank Slope (*2)	5	vertical banks
Berm Width (*2) - Estimated	0	30 ft
Location of erosion	4	whole bank and toe
Bank Stability	5	vertical sections and caves
Site Relative to Bend	3	outside of a greater than 90 degree bend
Vegetation Cover	3	minimal, on upper bank only, 30%
Tree Hazard	0	no trees
Soil Type (*2)	2	clays with some silts
Velocity (*2)	4	5.64 ft/s
Human Usage	0	rare, too steep
Erosion Hazard	37	Calculate Erosion Hazard

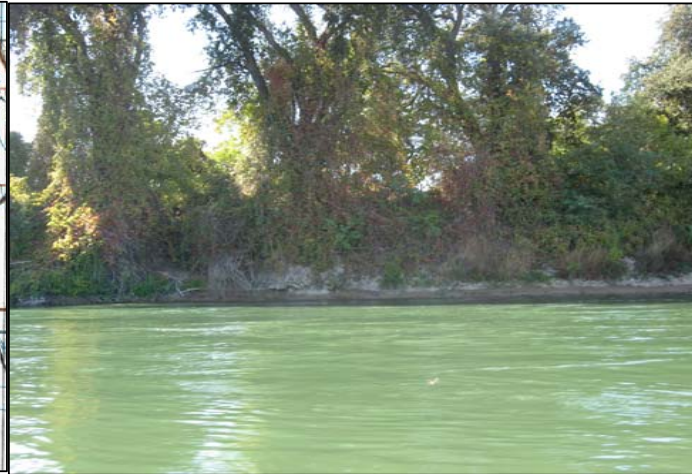
Site Photograph

Criteria	Score	Notes
Bank Slope (*2)	4	less than 1:1 slope, near vertical
Berm Width (*2) - Estimated	0	50 ft
Location of erosion	4	full bank and toe
Bank Stability	5	vertical sections and some animal holes
Site Relative to Bend	3	outside of a gentle bend
Vegetation Cover	1	70 to 80%
Tree Hazard	4	large trees with exposed roots
Soil Type (*2)	2	clays and silts
Velocity (*2)	4	5.69 ft/s
Human Usage	0	rare
Erosion Hazard	37	Calculate Erosion Hazard

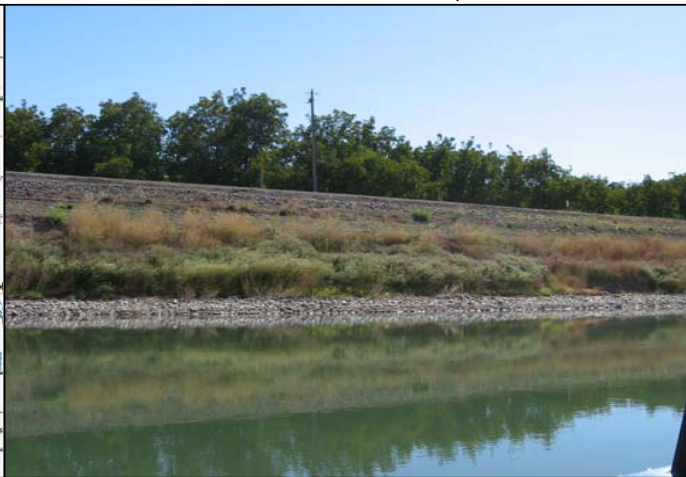
Site Photograph

Criteria	Score	Notes
Bank Slope (*2)	2	2:1 slope
Berm Width (*2) - Estimated	5	0 to 15 ft
Location of erosion	3	toe
Bank Stability	0	short vertical sections
Site Relative to Bend	2	just downstream of a bend
Vegetation Cover	1	60%
Tree Hazard	0	no trees
Soil Type (*2)	4	sands and silts
Velocity (*2)	3	3.32 ft/s
Human Usage	3	monthly
Erosion Hazard	37	Calculate Erosion Hazard

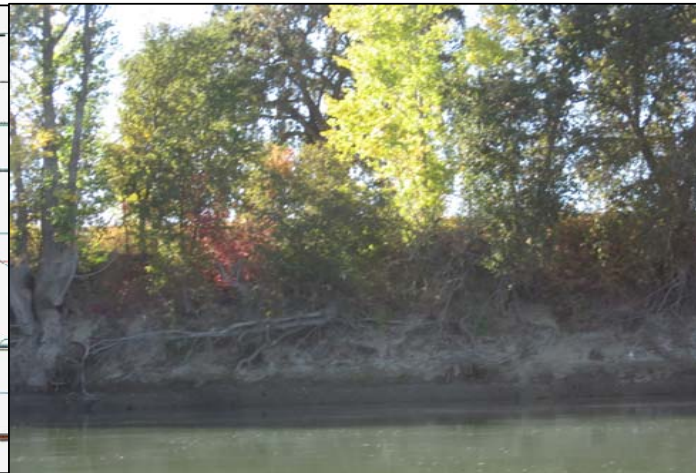
Site Photograph

Criteria	Score	Notes
Bank Slope (*2)	3	1.5:1 or less
Berm Width (*2) - Estimated	1	25 to 50 ft
Location of erosion	4	toe and bank
Bank Stability	3	caves greater than 4 ft
Site Relative to Bend	0	inside of a bend
Vegetation Cover	4	less than 20%
Tree Hazard	5	trees with exposed roots and leaning
Soil Type (*2)	2	clays and silts
Velocity (*2)	4	5.74 ft/s
Human Usage	1	occassional
Erosion Hazard	37	Calculate Erosion Hazard

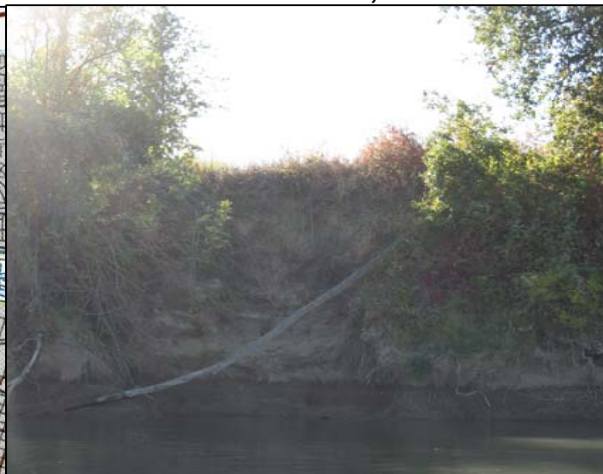
Site Photograph

Criteria	Score	Notes
Bank Slope (*2)	3	1.5:1 slope
Berm Width (*2) - Estimated	2	less than 20 ft
Location of erosion	3	toe
Bank Stability	2	vertical sections, less than half bank height
Site Relative to Bend	1	straight
Vegetation Cover	3	30%
Tree Hazard	5	large trees, exposed roots, some leaning
Soil Type (*2)	2	clays and silts
Velocity (*2)	2	2.87 ft/s
Human Usage	5	stairs down to bank, daily
Erosion Hazard	37	Calculate Erosion Hazard

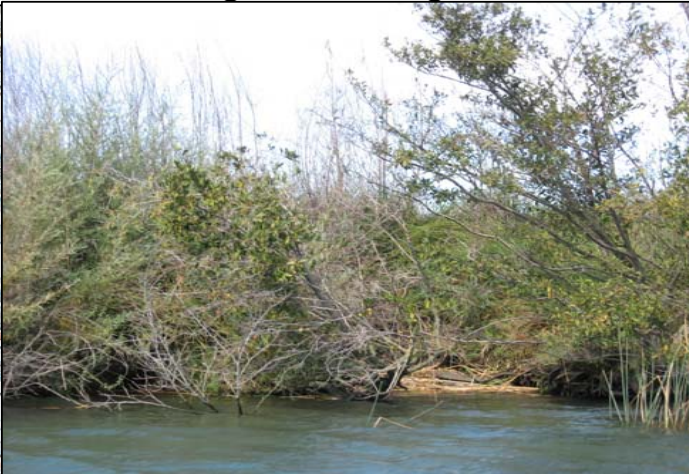
Site Photograph

Criteria	Score	Notes
Bank Slope (*2)	3	1.5:1 slope
Berm Width (*2) - Estimated	4	less than 5 ft
Location of erosion	4	toe and levee slope
Bank Stability	0	no vertical sections or caves
Site Relative to Bend	3	outside of a slight bend
Vegetation Cover	0	about 90%
Tree Hazard	0	small trees
Soil Type (*2)	4	sands and silts
Velocity (*2)	3	4.63 ft/s
Human Usage	2	one path down with grass growing over it, seasonal use
Erosion Hazard	37	Calculate Erosion Hazard

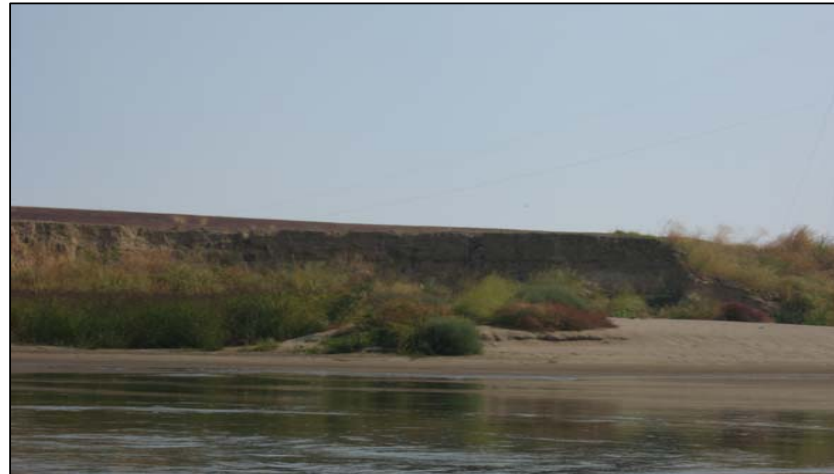
Site Photograph

Criteria	Score	Notes
Bank Slope (*2)	4	1:1 to 1.5:1 slopes
Berm Width (*2) - Estimated	1	25 ft
Location of erosion	4	full bank and toe
Bank Stability	2	vertical sections, full bank height
Site Relative to Bend	0	inside of a bend
Vegetation Cover	3	25%
Tree Hazard	0	no trees
Soil Type (*2)	4	sands and silts
Velocity (*2)	4	3.52 ft/s, plus eddy
Human Usage	1	occassional
Erosion Hazard	36	Calculate Erosion Hazard

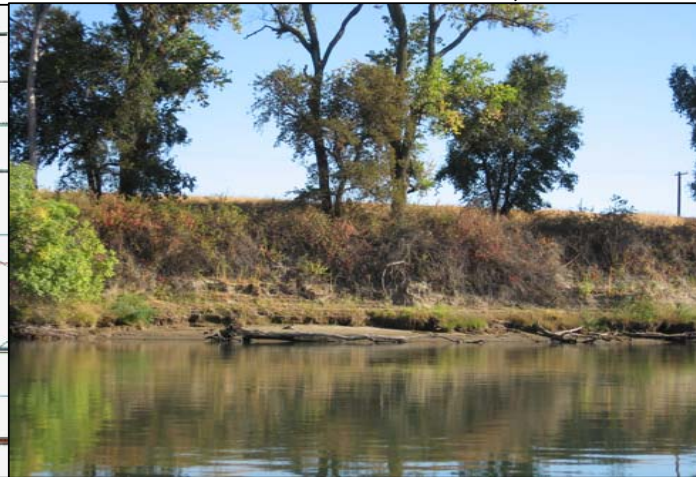
Site Photograph

Criteria	Score	Notes
Bank Slope (*2)	4	1:1 slope
Berm Width (*2) - Estimated	0	30 to 50 ft
Location of erosion	2	full bank
Bank Stability	5	vertical sections, greater than half bank height and caves
Site Relative to Bend	1	straight
Vegetation Cover	3	30%
Tree Hazard	3	large trees
Soil Type (*2)	2	clays and silts
Velocity (*2)	3	4.74 ft/s
Human Usage	4	weekly
Erosion Hazard	36	Calculate Erosion Hazard

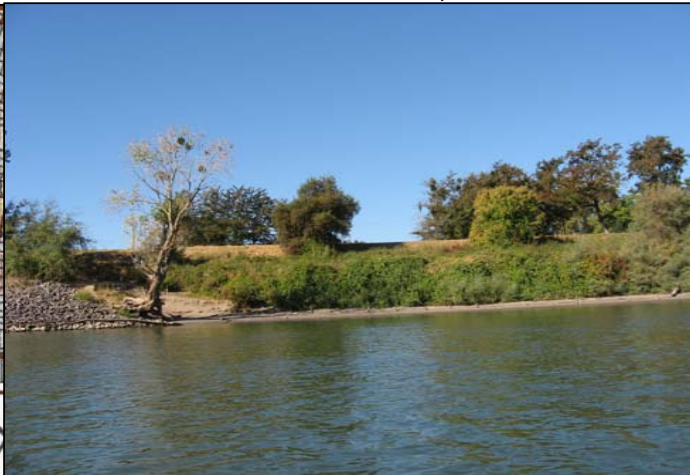
Site Photograph

Criteria	Score	Notes
Bank Slope (*2)	3	1.5:1 slope
Berm Width (*2) - Estimated	1	25 ft
Location of erosion	2	berm
Bank Stability	5	caves and vertical sections
Site Relative to Bend	1	straight
Vegetation Cover	0	80%
Tree Hazard	4	large trees with exposed roots
Soil Type (*2)	2	clays and silts
Velocity (*2)	4	5.11 ft/s
Human Usage	4	weekly, rope swing
Erosion Hazard	36	Calculate Erosion Hazard

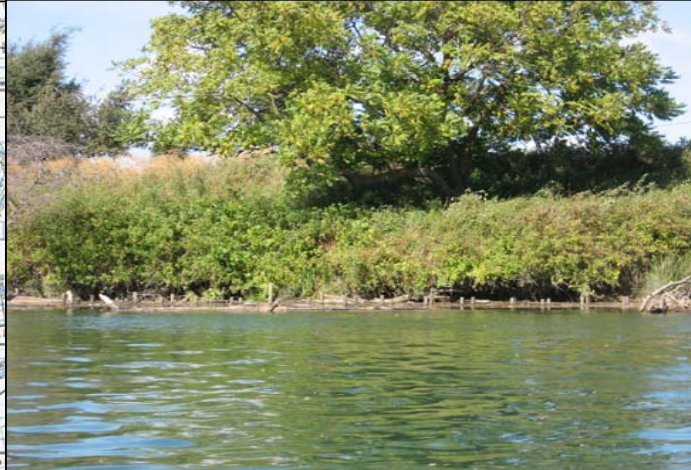
Georgiana Slough, RM 9.3L

Criteria	Score	Notes
Bank Slope (*2)	4	1:1 slope
Berm Width (*2) - Estimated	2	10 ft
Location of erosion	3	whole bank
Bank Stability	2	vertical sections, less than half bank height
Site Relative to Bend	5	outside of a sharp bend
Vegetation Cover	0	85%
Tree Hazard	2	medium trees
Soil Type (*2)	4	silts and sands
Velocity (*2)	1	1.07 ft/s
Human Usage	2	thick vegetation, seasonal
Erosion Hazard	36	Calculate Erosion Hazard

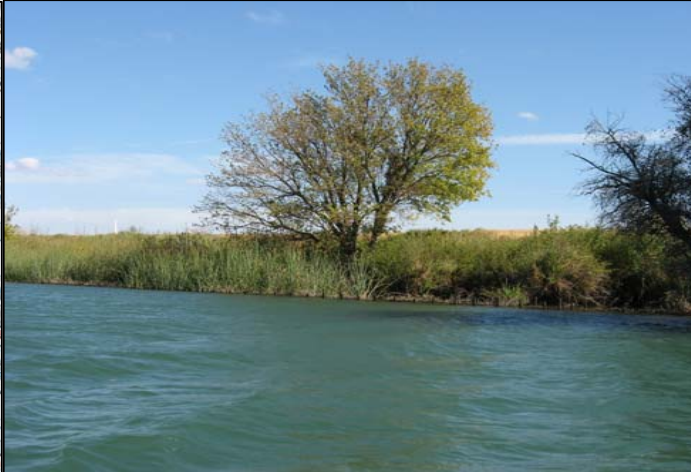
Georgiana Slough, RM 6.4L

Criteria	Score	Notes
Bank Slope (*2)	3	1.5:1 slope
Berm Width (*2) - Estimated	2	10 ft
Location of erosion	3	toe
Bank Stability	1	caves, small
Site Relative to Bend	1	straight
Vegetation Cover	1	70%
Tree Hazard	4	large trees and exposed roots
Soil Type (*2)	4	sands and silts
Velocity (*2)	3	3.78 ft/s
Human Usage	2	seasonal
Erosion Hazard	36	Calculate Erosion Hazard

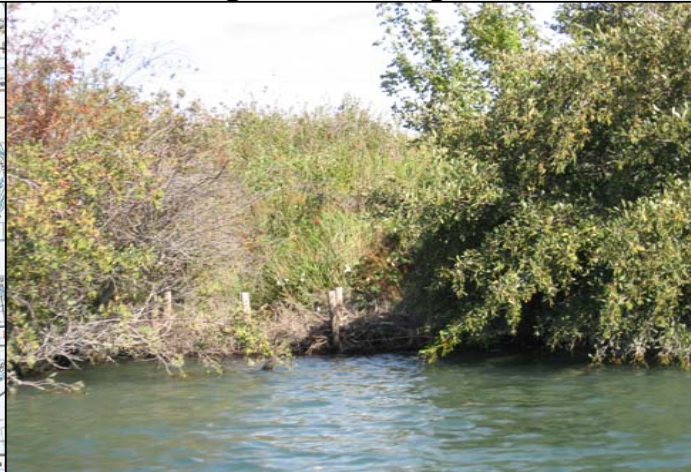
Georgiana Slough, RM 3.6L

Criteria	Score	Notes
Bank Slope (*2)	2	2:1 slope
Berm Width (*2) - Estimated	4	less than 5 ft of berm
Length of erosion	4	1165 ft
Bank Stability	3	beaver burrow at toe, greater than 4 ft
Site Relative to Bend	0	inside of a bend
Vegetation Cover	0	90% cover
Tree Hazard	2	medium trees
Soil Type (*2)	4	sands and silts
Velocity (*2)	3	4.64 ft/s
Human Usage	1	occassional
Erosion Hazard	36	Calculate Erosion Hazard

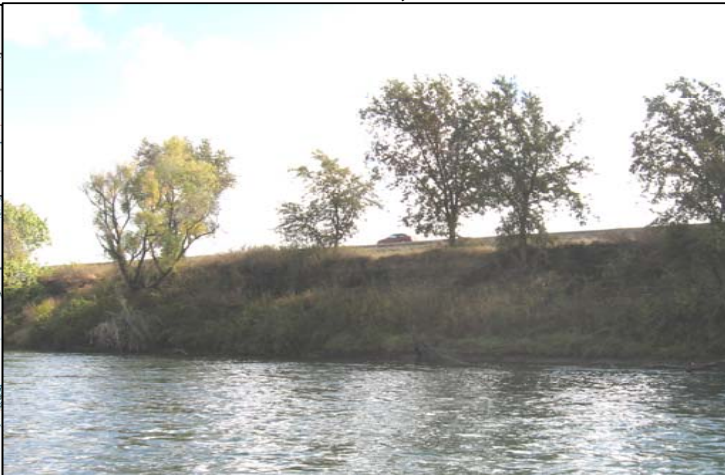
Feather River, RM 3.6L

Criteria	Score	Notes
Bank Slope (*2)	3	1.5:1 slope
Berm Width (*2) - Estimated	0	30 ft
Location of erosion	2	whole bank
Bank Stability	3	holes left from fallen trees, and erosion pockets
Site Relative to Bend	1	straight
Vegetation Cover	0	80 to 90%
Tree Hazard	4	large trees with visible roots
Soil Type (*2)	4	sands and silts
Velocity (*2)	4	7.23 ft/s
Human Usage	4	Path down, a bare spot that appears to be used by humans
Erosion Hazard	36	Calculate Erosion Hazard

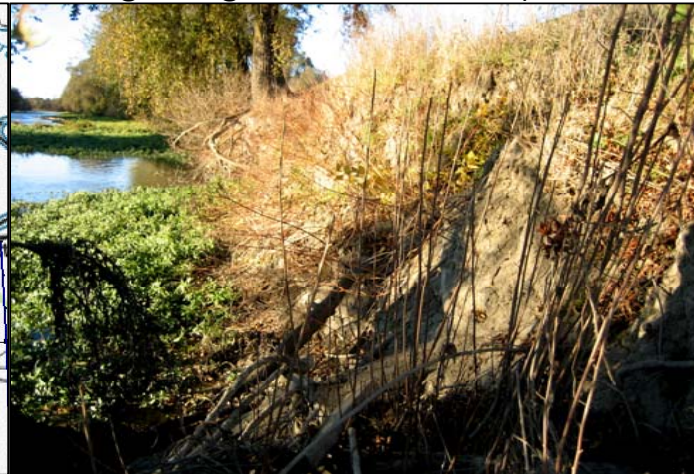
Knights Landing Ridge Cut, LM 3.1 (KLRD Unit 2 East)

Criteria	Score	Notes
Bank Slope (*2)	2	2:1 slope
Berm Width (*2) - Estimated	5	no berm
Location of erosion	4	toe and lower slope
Bank Stability	5	pipng holes and vertical sections
Site Relative to Bend	3	outside of a gentle bend
Vegetation Cover	1	60 to 70%
Tree Hazard	4	large trees, exposed roots
Soil Type (*2)	2	silts with some clays
Velocity (*2)	0	0.1 ft/s
Human Usage	1	occassional, no access but close to town
Erosion Hazard	36	Calculate Erosion Hazard

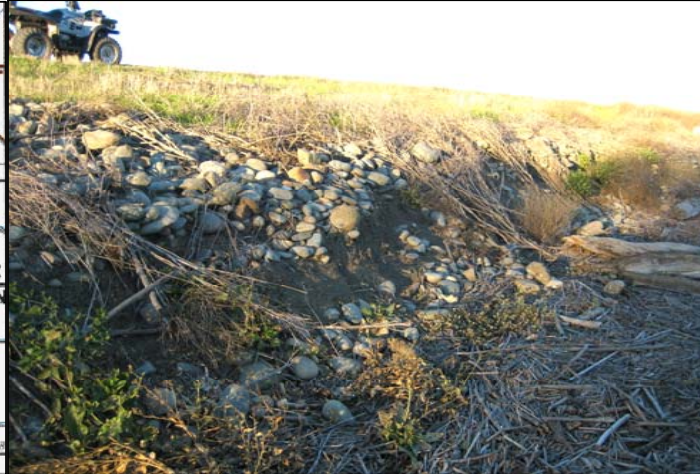
Yolo Bypass, LM 2.6 (DWR Unit 1 West)

Criteria	Score	Notes
Bank Slope (*2)	2	2:1 slope
Berm Width (*2) - Estimated	5	no berm
Location of erosion	4	toe and lower slope
Bank Stability	4	vertical sections, about half bank height
Site Relative to Bend	1	straight
Vegetation Cover	2	medium cover
Tree Hazard	0	no trees
Soil Type (*2)	4	sands and silts
Velocity (*2)	1	1.5 ft/s
Human Usage	1	occassional
Erosion Hazard	36	Calculate Erosion Hazard

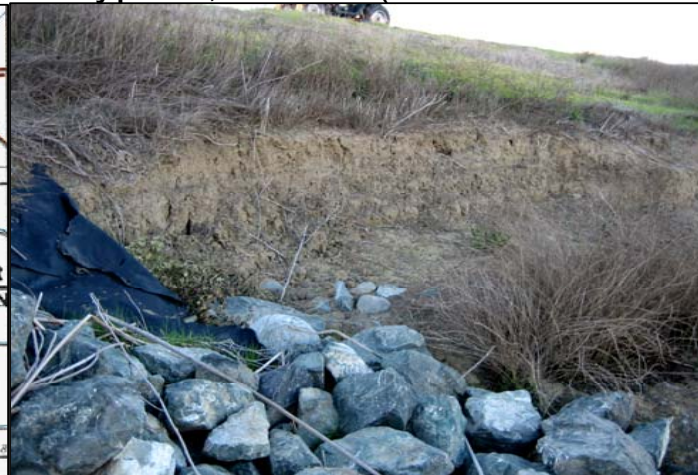
Yolo Bypass, LM 2.5 (DWR Unit 1 West)

Criteria	Score	Notes
Bank Slope (*2)	2	2:1 slope
Berm Width (*2) - Estimated	5	no berm
Location of erosion	4	toe and lower slope
Bank Stability	4	vertical sections about half bank height
Site Relative to Bend	1	straight
Vegetation Cover	2	50%
Tree Hazard	0	no trees
Soil Type (*2)	4	sands and silts
Velocity (*2)	1	1.5 ft/s
Human Usage	1	occassional
Erosion Hazard	36	Calculate Erosion Hazard

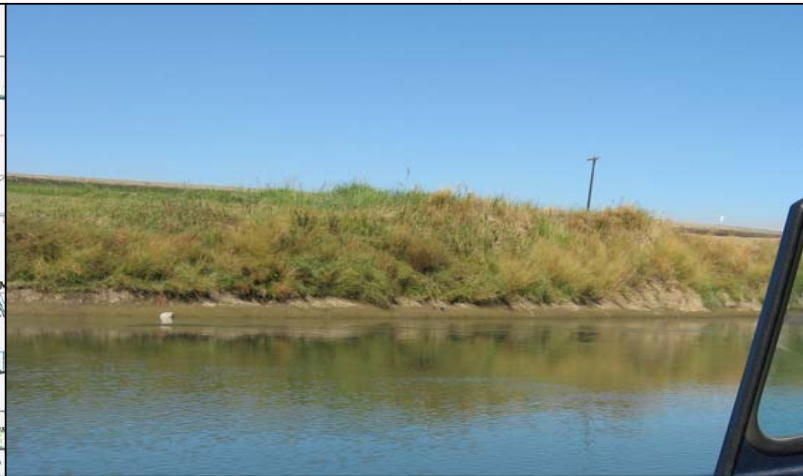
Sacramento River, RM 96.2L

Criteria	Score	Notes
Bank Slope (*2)	4	1:1 slope
Berm Width (*2) - Estimated	0	30 ft
Location of erosion	4	full bank and toe
Bank Stability	5	vertical sections and caves
Site Relative to Bend	1	relatively straight
Vegetation Cover	3	30 - 40%
Tree Hazard	0	no trees
Soil Type (*2)	4	sands and silts
Velocity (*2)	3	3.23 ft/s
Human Usage	0	rare, too steep
Erosion Hazard	35	Calculate Erosion Hazard

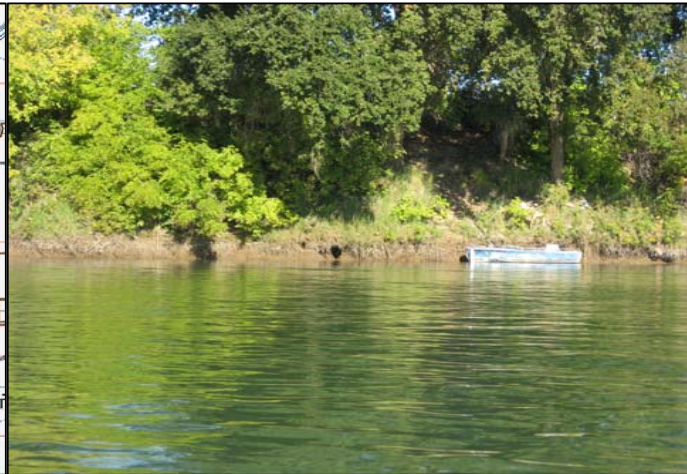
Sacramento River, RM 78.8L

Criteria	Score	Notes
Bank Slope (*2)	3	1.5:1 slope
Berm Width (*2) - Estimated	0	35 ft
Location of erosion	3	toe
Bank Stability	5	vertical sections less than half bank height and caves
Site Relative to Bend	3	outside of a gentle bend
Vegetation Cover	1	60 - 70%
Tree Hazard	3	large trees
Soil Type (*2)	4	sands and silts
Velocity (*2)	3	4.82 ft/s
Human Usage	0	rare
Erosion Hazard	35	Calculate Erosion Hazard

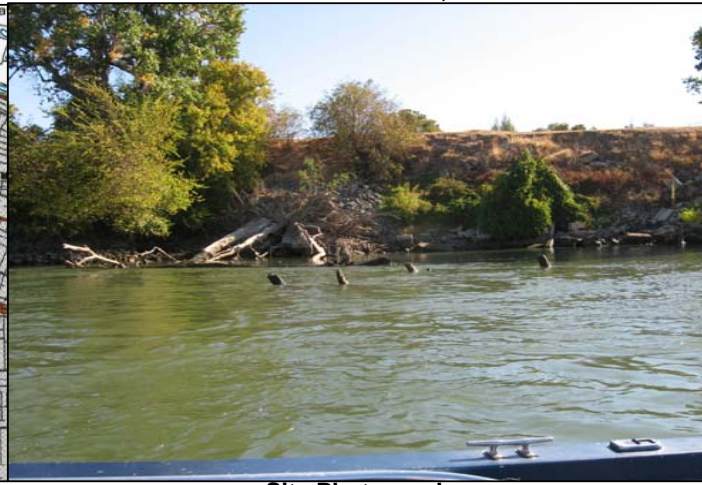
Sacramento River, RM 56.6L

Criteria	Score	Notes
Bank Slope (*2)	3	1.5:1
Berm Width (*2) - Estimated	0	125 ft
Location of erosion	4	levee slope and toe
Bank Stability	2	small vertical sections
Site Relative to Bend	1	straight
Vegetation Cover	3	40%
Tree Hazard	3	large trees, one recently fallen
Soil Type (*2)	4	sands and silts
Velocity (*2)	4	5.11 ft/s
Human Usage	0	gate on top, rare
Erosion Hazard	35	Calculate Erosion Hazard

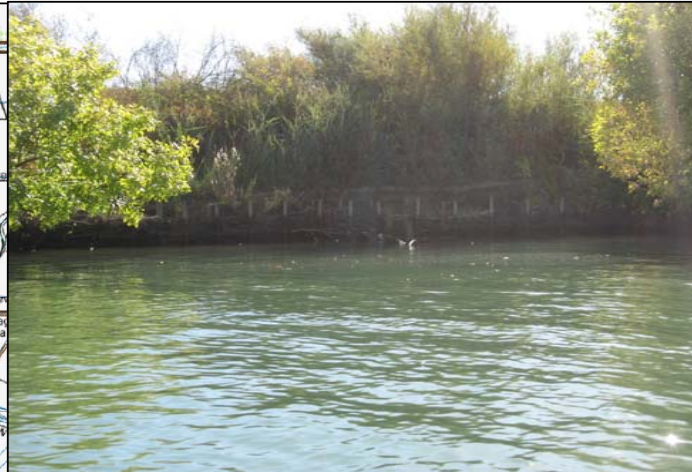
Sacramento River, RM 25.2L

Criteria	Score	Notes
Bank Slope (*2)	4	1:1 slope
Berm Width (*2) - Estimated	2	10 ft
Location of erosion	2	berm slope
Bank Stability	2	vertical sections, less than half bank height
Site Relative to Bend	1	straight
Vegetation Cover	1	80%
Tree Hazard	4	large trees with exposed roots
Soil Type (*2)	2	clays and silts
Velocity (*2)	3	4.54 ft/s
Human Usage	3	monthly, some debris
Erosion Hazard	35	Calculate Erosion Hazard

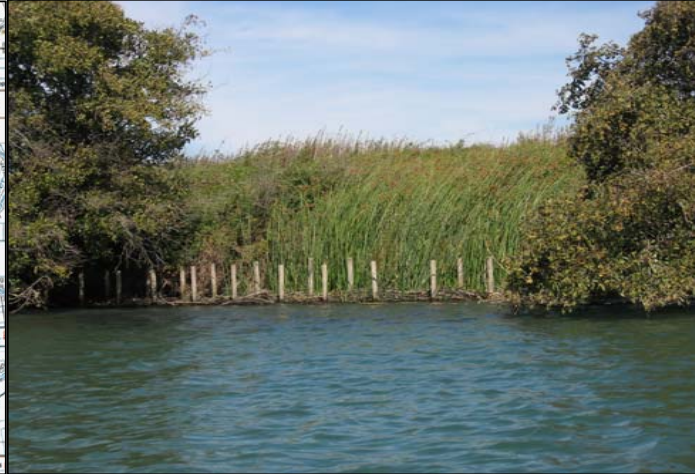
Georgiana Slough, RM 1.7L

Criteria	Score	Notes
Bank Slope (*2)	2	2:1 slope
Berm Width (*2) - Estimated	4	less than 5 ft
Location of erosion	3	toe
Bank Stability	3	beaver burrows, greater than 4 ft
Site Relative to Bend	1	straight
Vegetation Cover	0	95%
Tree Hazard	2	medium trees
Soil Type (*2)	4	sands and silts
Velocity (*2)	3	4.05 ft/s
Human Usage	0	Vegetation too dense for human access
Erosion Hazard	35	Calculate Erosion Hazard

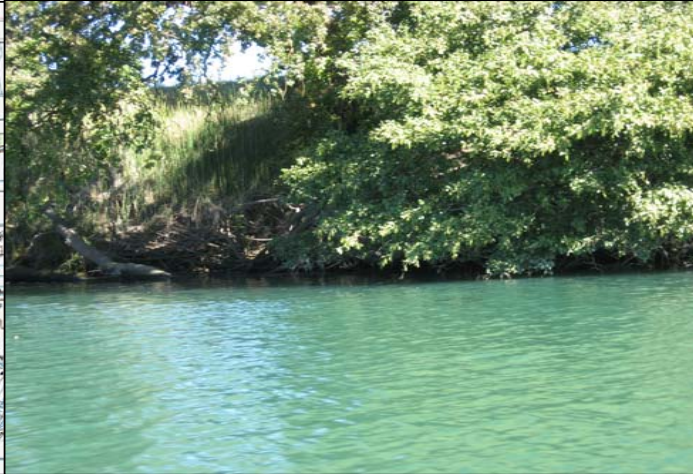
Steamboat Slough, RM 25.0L

Criteria	Score	Notes
Bank Slope (*2)	3	1.5:1 slope
Berm Width (*2) - Estimated	3	5 ft
Location of erosion	2	lower bank
Bank Stability	1	caves from tree popouts
Site Relative to Bend	1	straight
Vegetation Cover	2	60%
Tree Hazard	5	large trees, exposed roots and leaning
Soil Type (*2)	2	clays and silts
Velocity (*2)	3	4.48 ft/s
Human Usage	2	seasonal
Erosion Hazard	35	Calculate Erosion Hazard

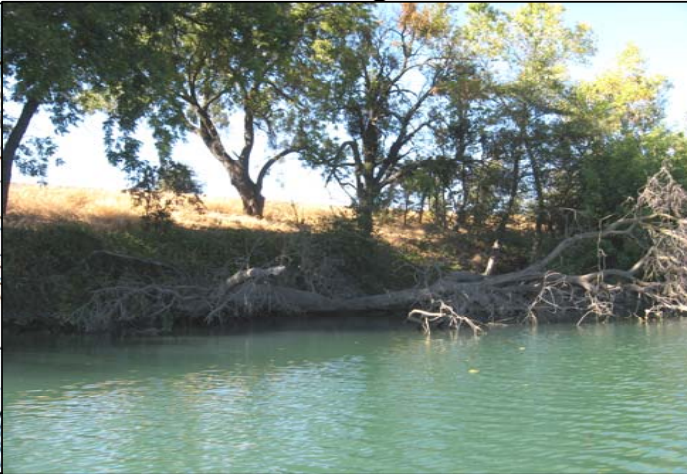
Elk Slough, RM 0.2

Criteria	Score	Notes
Bank Slope (*2)	4	1:1 slope
Berm Width (*2) - Estimated	5	no berm
Location of erosion	1	levee slope
Bank Stability	2	vertical sections, less than half bank height
Site Relative to Bend	1	straight
Vegetation Cover	0	dense, 80 to 90%
Tree Hazard	4	large trees with exposed roots
Soil Type (*2)	1	clays
Velocity (*2)	2	3 ft/s
Human Usage	3	near highway, monthly
Erosion Hazard	35	Calculate Erosion Hazard

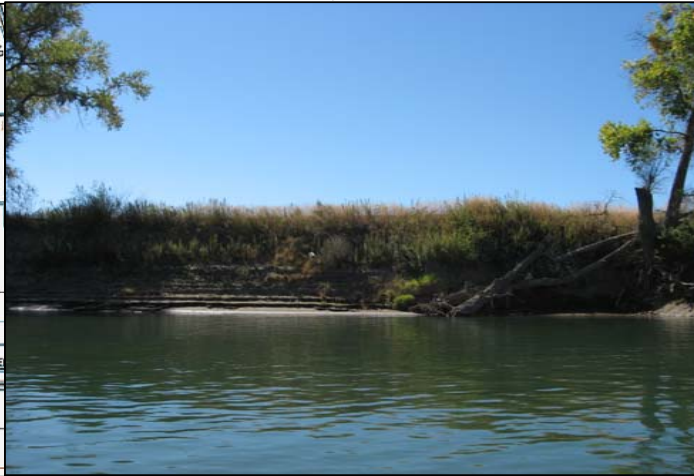
Sacramento River, RM 122.3R

Criteria	Score	Notes
Bank Slope (*2)	3	1.5:1 slope
Berm Width (*2) - Estimated	0	40 ft
Location of erosion	4	bank and toe
Bank Stability	2	short vertical sections
Site Relative to Bend	1	straight
Vegetation Cover	2	40 - 50%
Tree Hazard	4	large trees, exposed roots
Soil Type (*2)	2	clays and silts
Velocity (*2)	4	5.48 ft/s
Human Usage	3	monthly
Erosion Hazard	34	Calculate Erosion Hazard

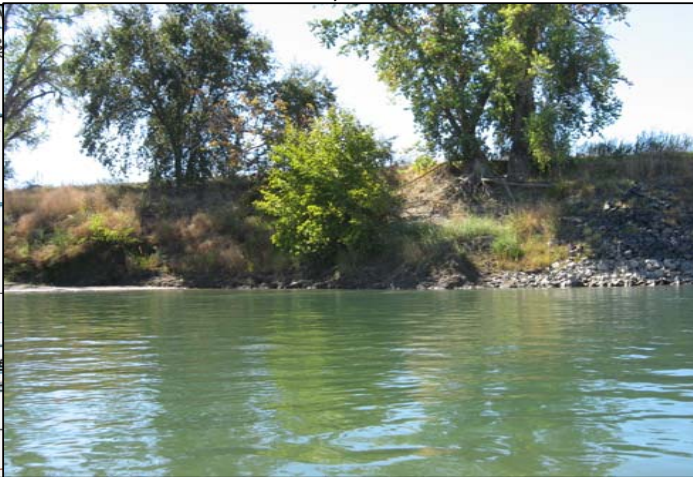
Sacramento River, RM 122.0R

Criteria	Score	Notes
Bank Slope (*2)	2	2:1 slope
Berm Width (*2) - Estimated	0	40 ft
Location of erosion	4	lower bank and toe
Bank Stability	4	vertical sections greater than half bank height
Site Relative to Bend	0	inside of a bend
Vegetation Cover	2	40%
Tree Hazard	5	large trees, exposed roots and leaning
Soil Type (*2)	2	clays and silts
Velocity (*2)	4	5.01 ft/s
Human Usage	3	monthly
Erosion Hazard	34	Calculate Erosion Hazard

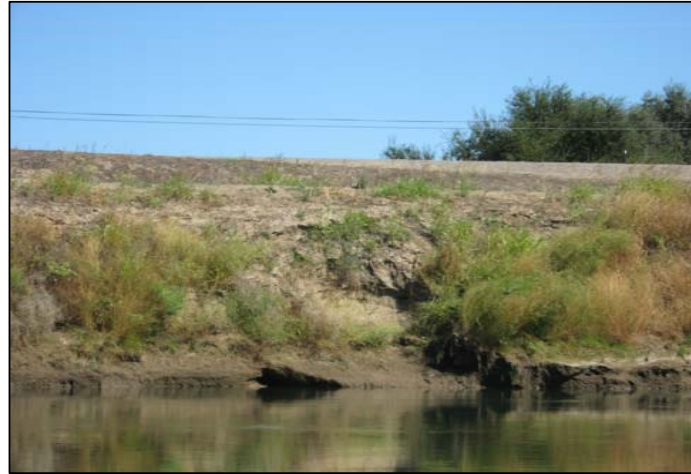
Sacramento River, RM 116.0L

Criteria	Score	Notes
Bank Slope (*2)	4	1.5: slope
Berm Width (*2) - Estimated	0	30 ft
Location of erosion	4	toe and berm
Bank Stability	2	vertical sections, less than half bank height
Site Relative to Bend	1	straight
Vegetation Cover	2	60%
Tree Hazard	0	no trees
Soil Type (*2)	4	sands and silts
Velocity (*2)	3	4.35 ft/s
Human Usage	3	monthly
Erosion Hazard	34	Calculate Erosion Hazard

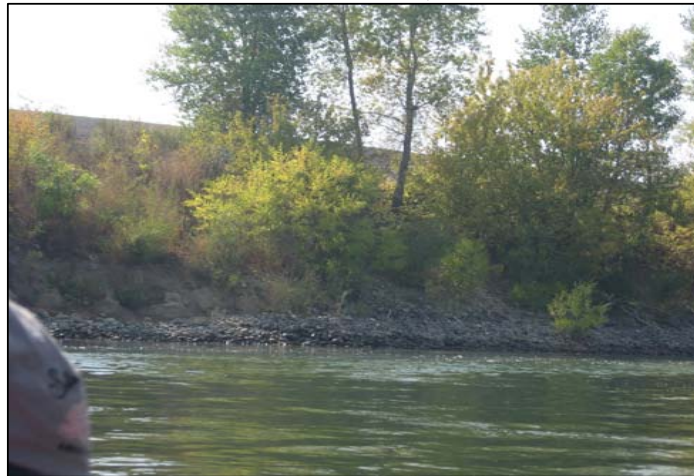
Sacramento River, RM 101.3R

Criteria	Score	Notes
Bank Slope (*2)	4	1:1 slope
Berm Width (*2) - Estimated	2	greater than 10 ft
Location of erosion	3	toe
Bank Stability	5	caves less than 4 ft and some vertical sections
Site Relative to Bend	1	straight
Vegetation Cover	2	50%
Tree Hazard	0	small trees
Soil Type (*2)	2	clays and silts
Velocity (*2)	3	3.22 ft/s
Human Usage	1	occassional
Erosion Hazard	34	Calculate Erosion Hazard

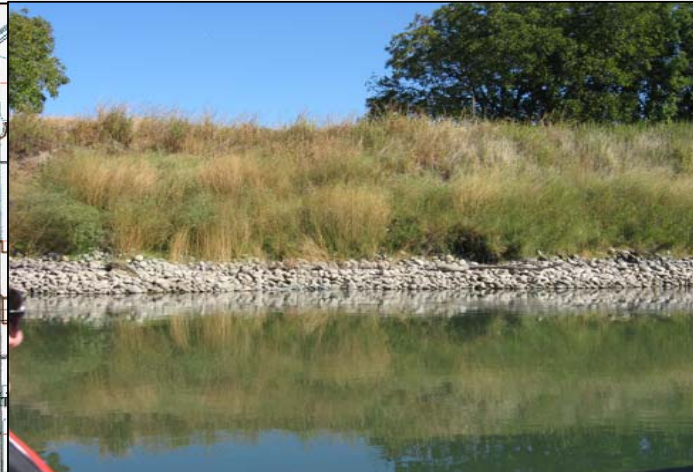
Sacramento River, RM 86.3L

Criteria	Score	Notes
Bank Slope (*2)	3	1.5:1 slope
Berm Width (*2) - Estimated	0	30 to 50 ft
Location of erosion	3	toe
Bank Stability	5	vertical sections less than half bank height and caves
Site Relative to Bend	3	outside of a gentle bend
Vegetation Cover	2	about 50%
Tree Hazard	0	no trees on bank
Soil Type (*2)	4	sands and silts
Velocity (*2)	3	3.35 ft/s
Human Usage	1	occassional
Erosion Hazard	34	Calculate Erosion Hazard

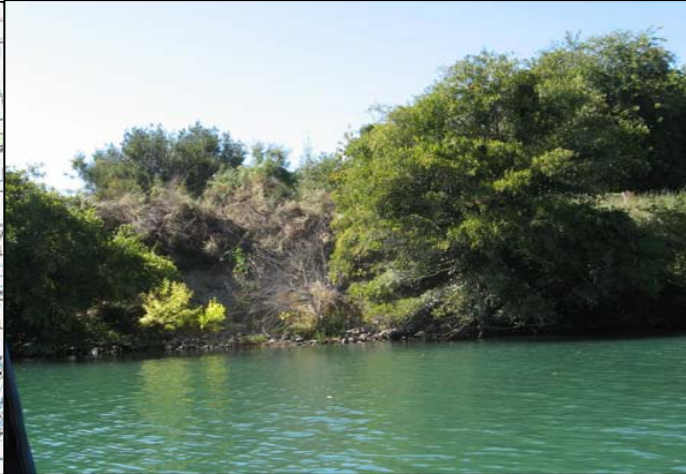
Steamboat Slough, RM 24.7R

Criteria	Score	Notes
Bank Slope (*2)	4	1:1 slope
Berm Width (*2) - Estimated	3	5 ft
Location of erosion	2	full bank
Bank Stability	2	some vertical sections
Site Relative to Bend	0	inside of a bend
Vegetation Cover	1	75%
Tree Hazard	4	trees with exposed roots
Soil Type (*2)	2	clays and silts
Velocity (*2)	3	4.67 ft/s
Human Usage	1	occassional
Erosion Hazard	34	Calculate Erosion Hazard

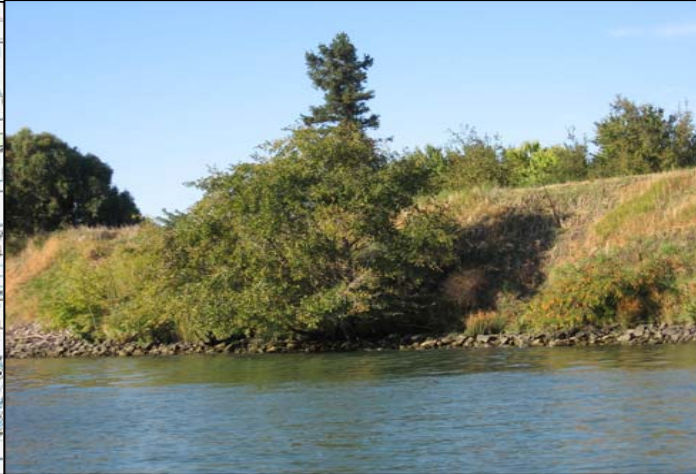
Site Photograph

Criteria	Score	Notes
Bank Slope (*2)	4	1:1 slope
Berm Width (*2) - Estimated	5	no berm
Location of erosion	1	levee slope
Bank Stability	0	no vertical sections or caves
Site Relative to Bend	1	straight
Vegetation Cover	0	90%
Tree Hazard	1	young trees
Soil Type (*2)	2	clays and silts
Velocity (*2)	3	3.72 ft/s
Human Usage	3	monthly
Erosion Hazard	34	Calculate Erosion Hazard

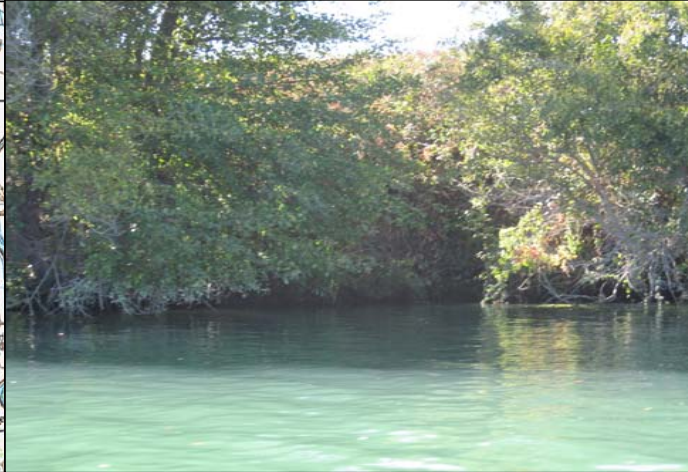
Site Photograph

Criteria	Score	Notes
Bank Slope (*2)	2	2:1 slope
Berm Width (*2) - Estimated	3	5 ft
Location of erosion	2	lower bank
Bank Stability	2	vertical sections, half bank height
Site Relative to Bend	3	outside of a gentle bend
Vegetation Cover	0	80%
Tree Hazard	4	small to medium trees, exposed roots
Soil Type (*2)	2	clays and silts
Velocity (*2)	3	4.73 ft/s
Human Usage	3	monthly
Erosion Hazard	34	Calculate Erosion Hazard

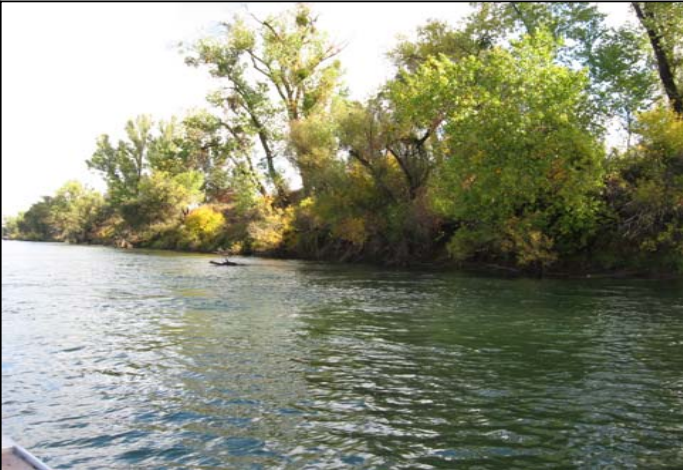
Site Photograph

Criteria	Score	Notes
Bank Slope (*2)	3	1.5:1 slope
Berm Width (*2) - Estimated	0	greater than 30 ft
Location of erosion	1	berm
Bank Stability	0	no vertical sections or burrows
Site Relative to Bend	1	straight
Vegetation Cover	1	60 to 70% cover
Tree Hazard	4	trees with visible roots
Soil Type (*2)	4	sands and silts
Velocity (*2)	5	8.79 ft/s
Human Usage	3	monthly
Erosion Hazard	34	Calculate Erosion Hazard
